The deterioration of Apuan white marble in contemporary architectural context

Research aim:

This paper reports the results obtained from the analyses carried out on marble slabs used as floor, cladding and sloping roof of the Oslo Opera House in order to understand the causes of the intense yellow discoloration and to investigate their state of conservation aiming to define new guidelines for the maintenance of the building.

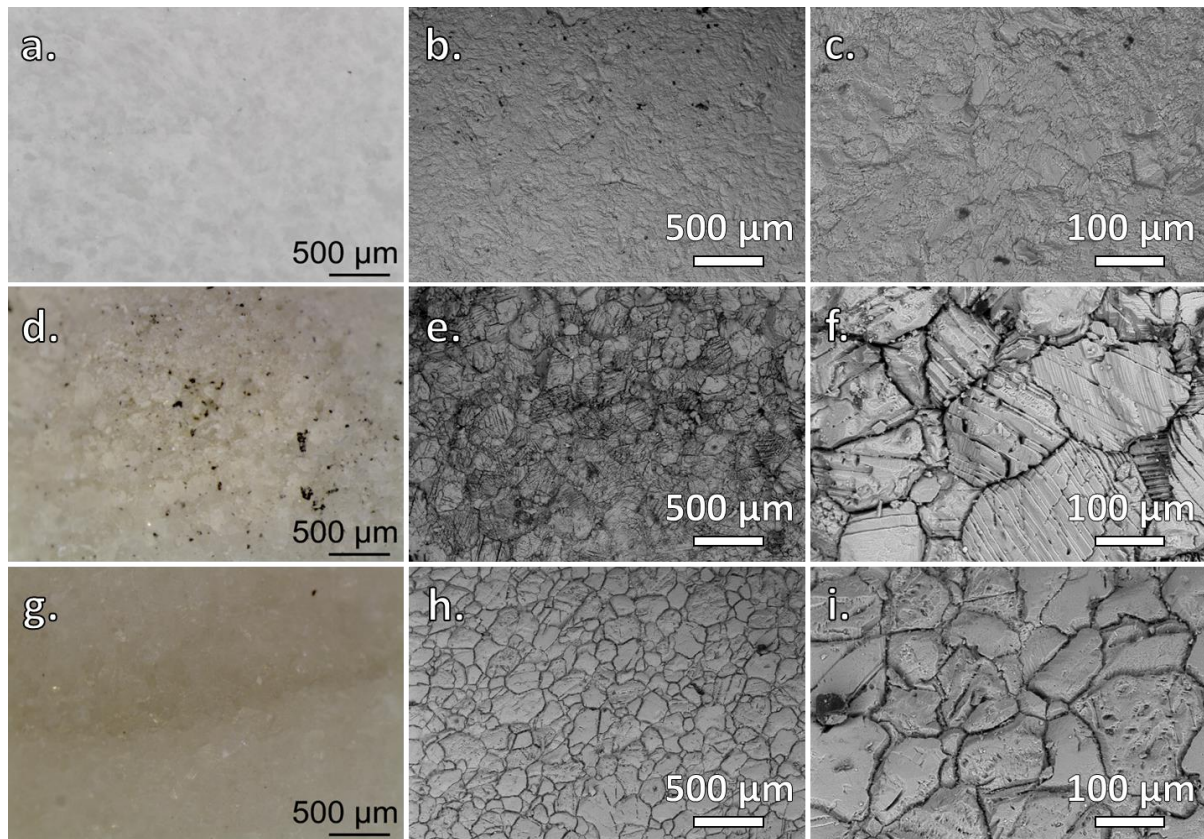
The crystal structure of the unexposed reference slab is very compact and the boundaries of calcite grains are almost not visible (Figure 4 b. and c.). This morphology, which is peculiar of a sound Apuan marble microstructure, can be highlighted also in the cross-section observations (Figure 6 a.). The surface of exposed slabs is rather different, as far as an intense decohesion of the crystal fabric can be

detected [7, 14]. The grain boundaries can be clearly perceived with rounded edges and detachment empty spaces creating a network of microfissures (Figure 4 e., f., h. and i., Figure 5 b.-f.). Moreover, in the calcite crystals of hammered slabs (P1, P2, P3B), the cleavage planes are evidenced with the appearance of internal subparallel lines due to an ongoing intragranular corrosion phenomenon in the initial phase (Figure 4 f., Figure 5 b., c and e.). Observing the cross-sections of P1, P2, P3B slabs the surface is characterized by the network of microfractures (more than 200 μm inside the bulk of the material) and the incipient detachment of corroded surface grains (Figure 6). Slabs with a “sawn” finishing exhibit a crystalline microstructure with the same intergranular decohesion, whereas the single grain shows a better preservation of the internal crystalline microstructure (Figure 4 h. and i.). Only some isolated crystals are deteriorated and corroded, with microfractures that can be noticed on the surface at higher magnification (Figure 4 i., Figure 5 d. and f.). By observing the cross-section of the samples collected from P6 slab, one of the most altered in color, high granular decohesion can be observed not only on the surface (Figure 6 c.), where the grains are detached, but also inside the sample till about 2 mm. It is well evident that the different finishing surface working determine a different reaction of calcite grains towards environmental corrosion. The degradation phenomenon of the crystalline microstructure should be primarily ascribed to thermal excursions due to severe microclimatic Oslo condition, subjected to frequent and long freezing-thawing cycles [7, 14-16]. In addition, surface erosion phenomena caused by weather precipitations (rain and snow) and salt crystallization cycles due to Cl^- containing marine spray and therefore cyclic dissolution and re-crystallization of halite (NaCl) inside the surface porosity of the stone can play a significant role in the observed surface decay. The surface finishing of the marble slabs can have influenced their state of conservation, as the hammered ones evidenced a more intense corrosion and damage of the crystal grains.

Compared to the unexposed slab (Figure 4 a.), the exposed ones exhibit a general yellowing and brown/grey surface particulate deposit (Figure 4 d. and g.). In particular, the yellow discoloration penetrates in the marble for about 20 mm (Figure S1). At higher magnifications, solid materials with different morphologies can be observed (Figure 6). The elemental compositions of the deposits show Na, Mg, Al, Si, S, Cl and K peaks related to environmental deposits and sea spray (Figure 7 a. and b.). It is important to highlight that on the yellowed surface of the exposed slabs, iron (Fe) was scarcely detected by EDX analyses, and only very few grains of pyrite can be observed, pertaining to the mineral composition of the marble. On the “sawn” slabs (P3A and P6) the surface deposits accumulate both on the surface and inside the micro-cavities of the grains. In particular, some darker areas in BSE can be evidenced with the accumulation of “drops” of organic materials (Figure 7 c.). The elemental analysis of these areas exhibits high peaks of Si and C (Figure 6 c.) that can be ascribed, therefore, to

Figure 4. Optical and BSE-ESEM images of surface of unexposed reference (a., b., c.) and exposed P1 (d., e., f.) and P6 (g., h., i.) slabs.

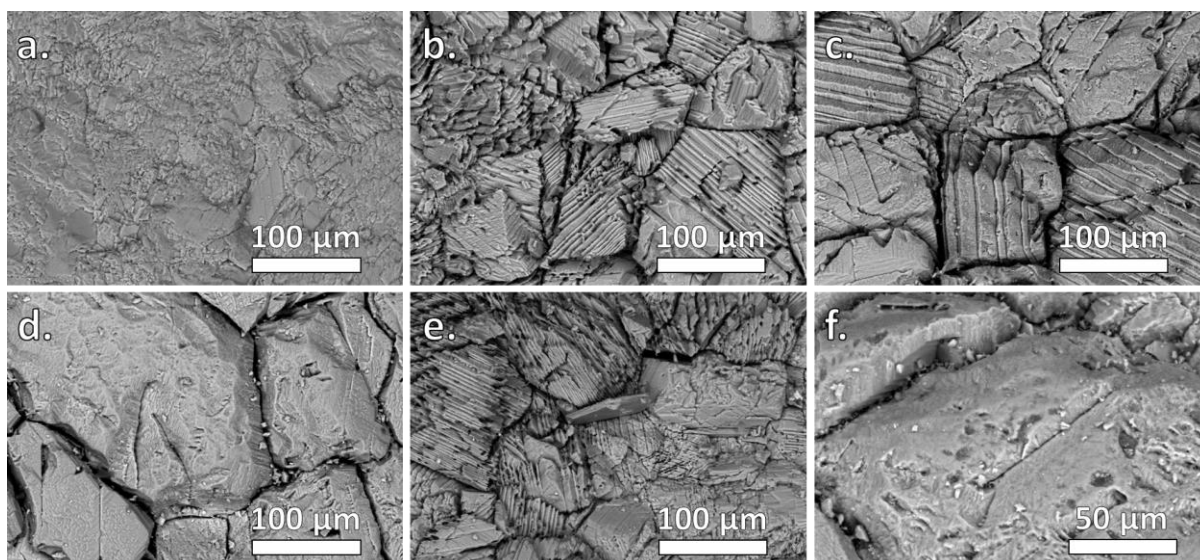
Figure 5. BSE-ESEM images of surface of unexposed reference (a.) and exposed P1 (b.), P2 (c.), P3A (d.), P3B (e.) and P6 (f.) slabs.

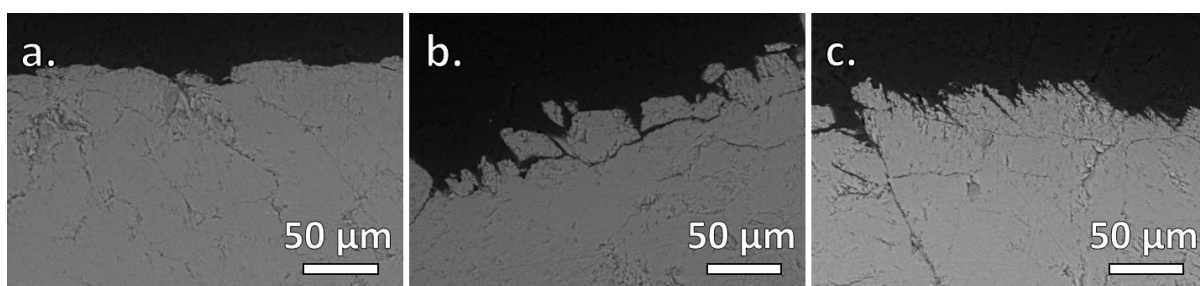
organosilicon treatments applied on the surface (these materials have been also investigated by micro-FTIR spectroscopy). Moreover, on the surface of some grains from the sample collected from P6 slab, a sporadic accumulation of organic deposit, characterized by the presence of F, C and Si in the EDX spectrum, was detected. As already reported in the introduction, the application of a fluorinated protective product, a “fluor acryl copolymer” was carried out just after cladding.

Figure 6. BSE-ESEM images of cross-sections of unexposed reference (a.) and exposed P2 (b.) and P6 (c.) slabs.

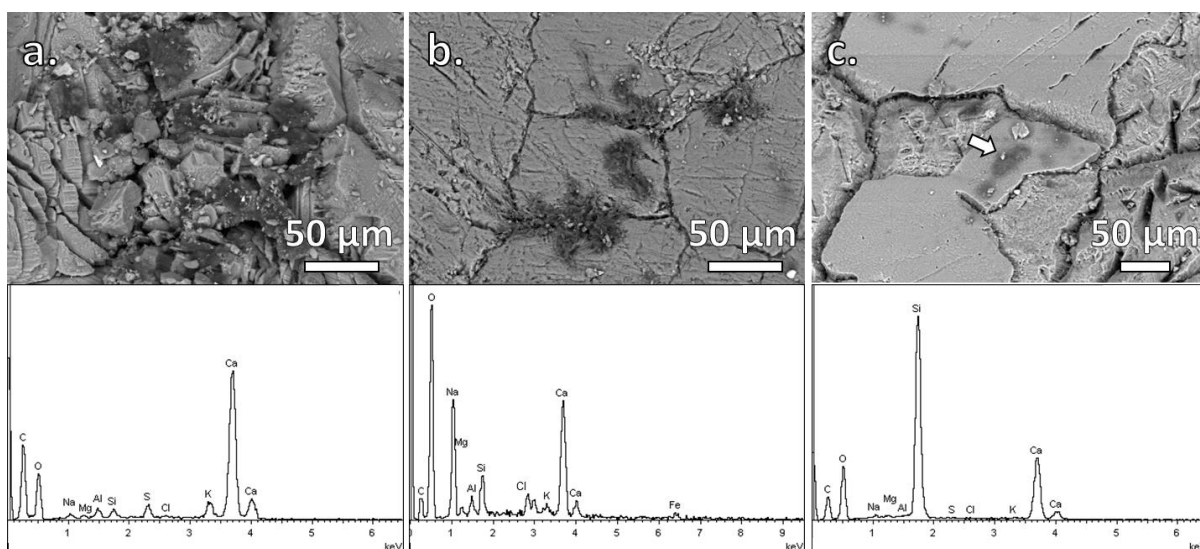
Figure 7. ESEM-EDX images of deposits on the surface of exposed P3B (a. and b.) and P6 (c.) slabs and elemental composition of the deposits.
